NCHRP 25-25/Task 72

CURRENT PRACTICES TO ADDRESS CONSTRUCTION VIBRATION AND POTENTIAL EFFECTS TO HISTORIC BUILDINGS ADJACENT TO TRANSPORTATION PROJECTS

Wilson, Ihrig & Associates, Inc.,
ICF International, and
Simpson, Gumpertz & Heger, Inc.

September 2012

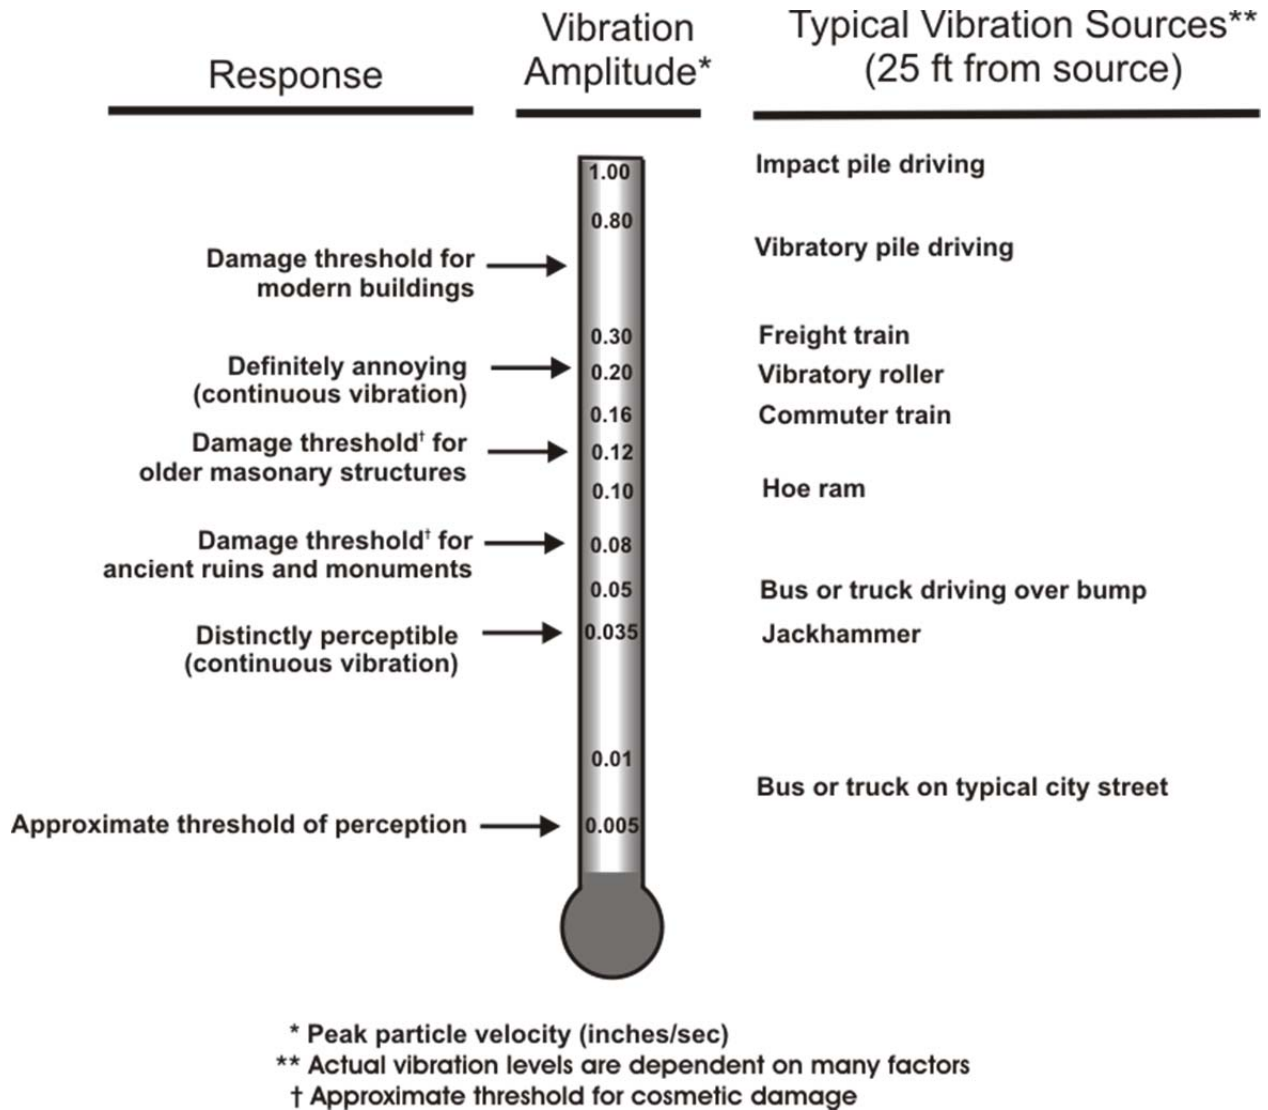
Figure 1. Typical Vibration Amplitudes and Thresholds

Figure 1 provides a comparison between typical vibration levels at 25 feet from various common sources and the response of humans (annoyance) and the potential for damage to historic buildings. The sensitivity of humans makes them aware of vibration at levels much lower than those that result in damage to most contemporary structures, although older historic buildings can be at risk in the transition range of vibration that is just barely perceptible (0.02 inches/sec) to vibration that most people would find definitely annoying (0.2 inches/sec).

Comparing the two sets of data (continuous and transient), it can be seen that there is approximately a factor of eight difference in the sensitivity to the nature of the vibration.

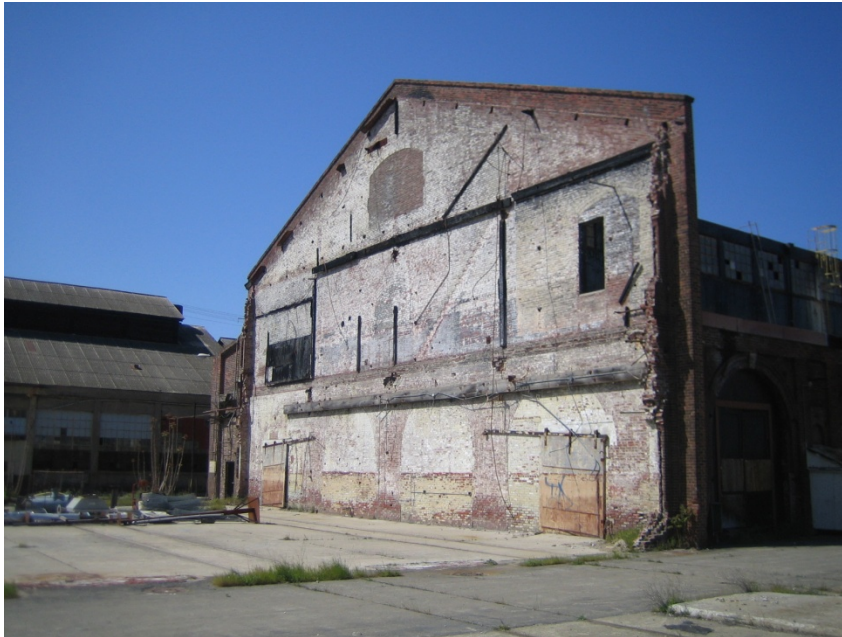
Figure 2. Car Shop within the Sacramento Railyards Central Shops Historic District

During the project’s design phase, the owner engaged a structural engineer to evaluate the condition of the buildings and the effect of future train vibration. The engineer concluded from a visual review that even though the maximum predicted vibration exceeded the FTA criterion, the vibration was not expected to cause any risk to the existing masonry walls (structural or cosmetic), with the exception of one building (Car Shop), which had a large cantilevered wall (i.e., unsupported laterally). Figure 2 shows the outside of the Car Shop’s unsupported wall.

The structural engineer conducted a detailed finite element analysis to evaluate the Car Shop wall and its susceptibility to ground vibration. The vibration consultant made additional vibration measurements for freight and passenger trains and characterized the site-specific soil conditions at the Car Shop. The additional data from measurements were used to refine the predicted vibration levels expected at the base of the cantilevered wall of the Car Shop.

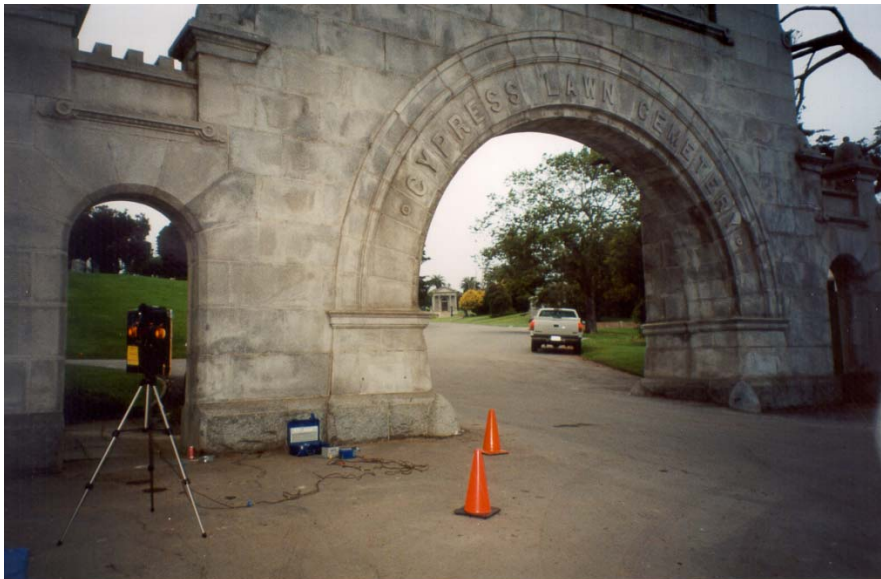
Figure 3. Cypress Lawn Cemetery Grand Gateway

Figure 3 shows the archway and a seismograph used for monitoring vibration. In addition to the seismograph at the base of the archway, there was an alarm system with warning lights (yellow for caution and red for exceedance) and an audible alarm. The warning system provided a direct feedback to the equipment operators when vibration limits were being approached or exceeded and allowed equipment operators to adjust their activity. After an initial learning stage of trial and error, the system became a reasonably successful tool to control vibration.

The implementation of the alarm system was somewhat unusual, but the cost was inconsequential because the seismograph was configured to allow for an alarm. The alarm's main advantage was that it allowed for real-time feedback to the equipment operator, thus increasing the chances of successful compliance with the vibration limit. In general, the response of the equipment operator to having an alarm was positive, and he was able to modify the activity of his equipment to stay within the vibration limits.

Vibration levels measured at the archway during construction of the BART project ranged from 0.09 to 0.12 inches/sec. The higher vibrations occurred during excavation and by movement of a small Caterpillar approximately 15 feet away from the archway. Although these levels were above the limit of 0.08 inches/sec, engineers found no damage to the archway during inspections during and after construction.

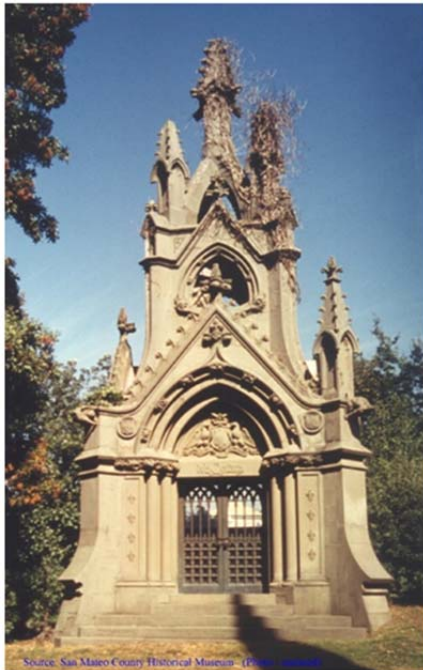
Figure 4. Cypress Lawn Cemetery de la Montaña Mausoleum

Figure 4 shows the de la Montaña Mausoleum. The mausoleum was constructed in 1907. The lower part of the structure is steel framed with sandstone cladding, while the upper part is a stone finial that sits on four stone arches atop four large granite blocks. At the time of BART subway construction, the de la Montaña Mausoleum was in a deteriorated condition due to lack of maintenance.

Based on the structure's age and condition, the vibration limit for the mausoleum was set at 0.08 inches/sec. To avoid any serious damage to the mausoleum and to protect its structural integrity, BART had the contractor install temporary interior shoring using scaffolding to support the structure at critical points. A structural engineer re-evaluated the vibration limit of 0.08 inches/sec and determined the limit could be raised to 0.138 inches/sec with the interior supports.

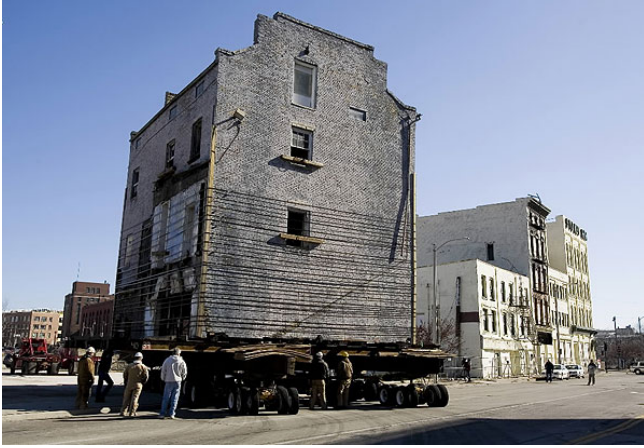
Figure 5. Gipfel Brewery building being moved

An interesting if sad footnote to this story, according to a 2009 newspaper article, was that, unrelated to the Park East project, the City of Milwaukee deemed the Gipfel building unstable and ordered the building owners to raze the building because it posed a threat to the safety and welfare of the public. The owners previously had moved it from its original location one block away with the intent of incorporating the brewery building into another development. However, the lead developer of the new project rejected this plan. The building owners still had hopes of saving the building, but, unfortunately, time ran out and the building was demolished in 2009. Figure 5 shows the building in the process of being moved.

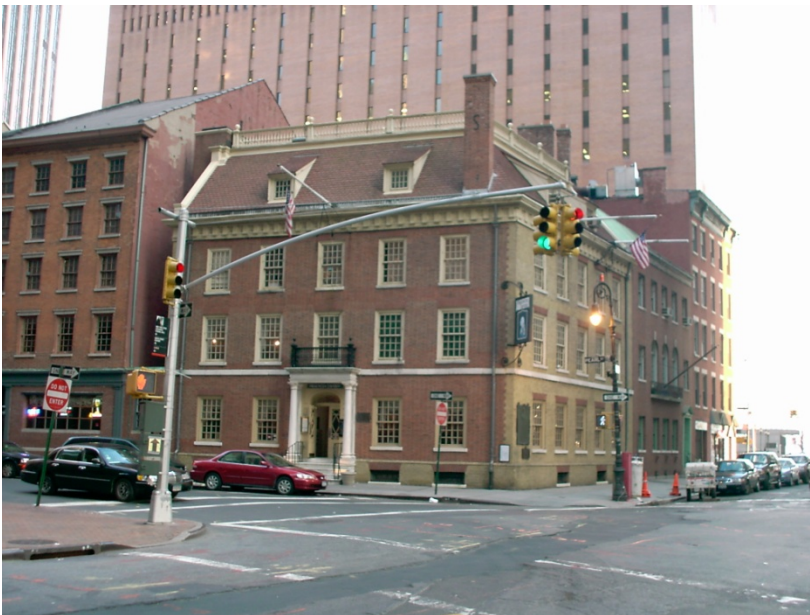
Figure 6. Fraunces Tavern.

The potentially affected buildings in the historic district were constructed between 1820 and 1970 on fill placed in the area during the 17th Century. The historic buildings included 16 three and six story buildings located on one city block. The engineers indicated in their investigation that some of the buildings had undergone extensive renovations. Figure 6 shows Fraunces Tavern, one of several historic buildings within the Fraunces Historic District.

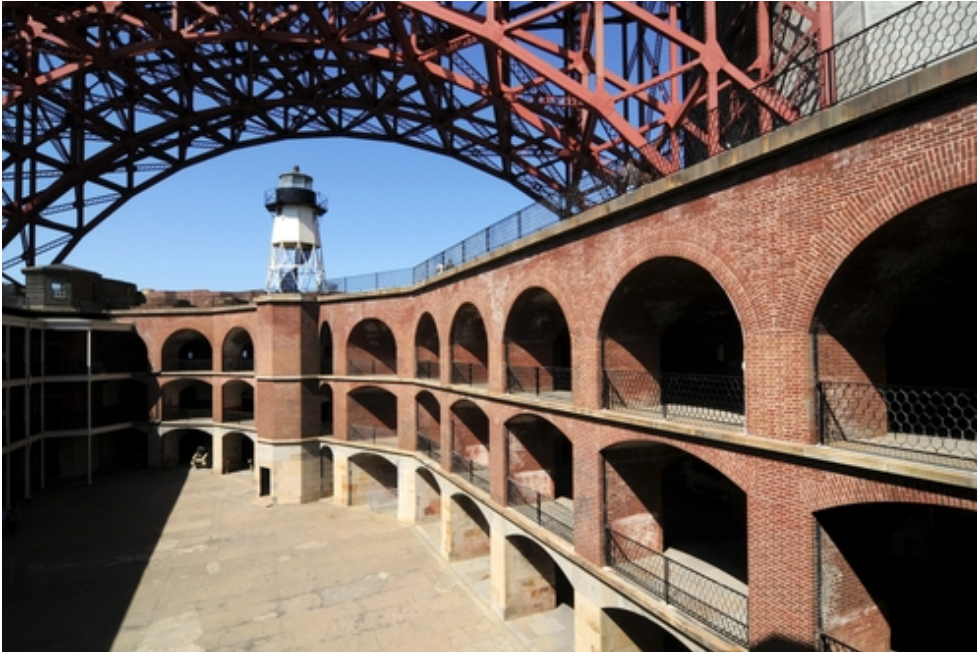
Figure 7. Fort Point and Golden Gate Bridge

Directly underneath the south end of the bridge is the historic Fort Point a masonry structure built in 1854. Figure 7 shows the inside of Fort Point with the bridge above. The contract specification for the bridge retrofit required vibration to be limited to less than 0.1 inches/sec for continuous activities and 1.0 inches/sec for single-event activities occurring near Fort Point.

During Phase 1 remediation, cast-in-drilled-hole (CIDH) piling and pile caps were added around the perimeter of the original bridge foundation pedestals. The interface of new concrete to existing concrete was strengthened with post-tensioning of monostrands, clamping the new footings to the pedestals of the existing foundations. The existing grade beams between the foundation pedestals were also substantially strengthened, and additional grade beams were constructed. After the existing towers supporting the bridge were removed, the second stage of the foundation retrofit proceeded. First, the remaining upper portions of the existing pedestals were demolished. Then, new upper pedestals were constructed and closure pours placed to incorporate these elements into the entire foundation system. The erection of a new tower followed.

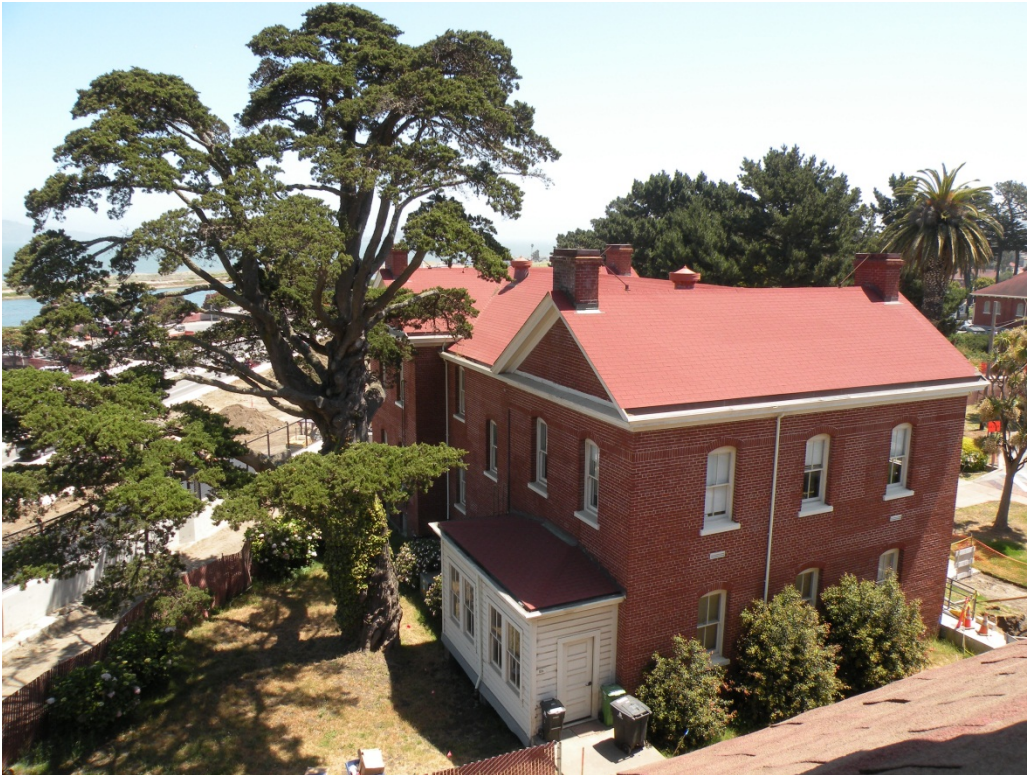
Figure 8. Buildings at the Presidio

“[A] ground vibration PPV of 2 mm/sec (0.08 inches/sec) would be a conservative, but appropriate limit for the historical buildings that are more susceptible to damage, including those in a poor structural condition and those of masonry construction. The buildings in the Main Post area of the Presidio are mostly of masonry construction and would therefore fall into this category. In addition, visual observation of the buildings under consideration in this study indicates some existing differential settlement and cracks in the facades of the brick buildings. However, most of the other historical buildings in the Presidio are wood-framed structures which are substantially less susceptible to damage from vibration. For most of these buildings, a higher PPV of 5 mm/sec (0.2 inches/sec) would be an appropriate, conservative limit for construction vibration. The exterior facades of some of these wood-framed buildings (such as the Mason Street warehouses) are in a poor condition, although it is understood that these buildings are structurally sound.”
